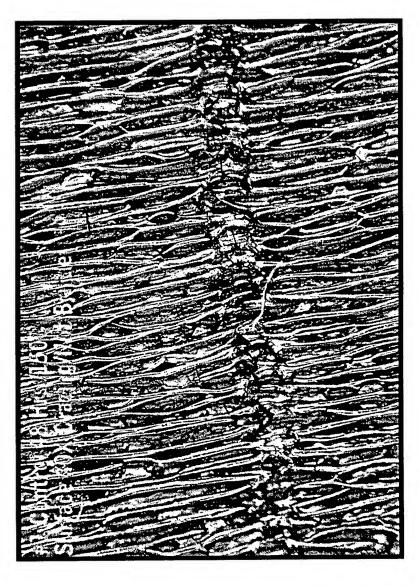
FIG. 1

Sample #1 Surface at 40X After 48 Hours at 150C

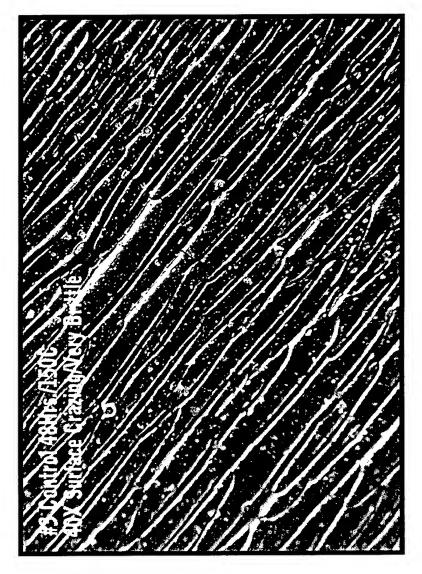
FIG. 2

Sample 3 Surface Photo 40X After 49 hours at 150C

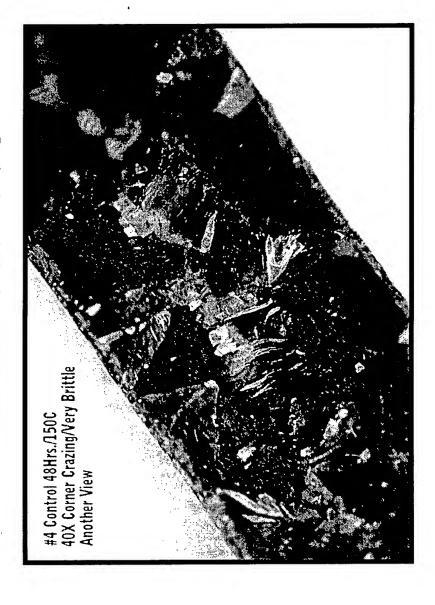
FIG. 4

Sample 4 Corner Shot 40X 48 Hours at 150C

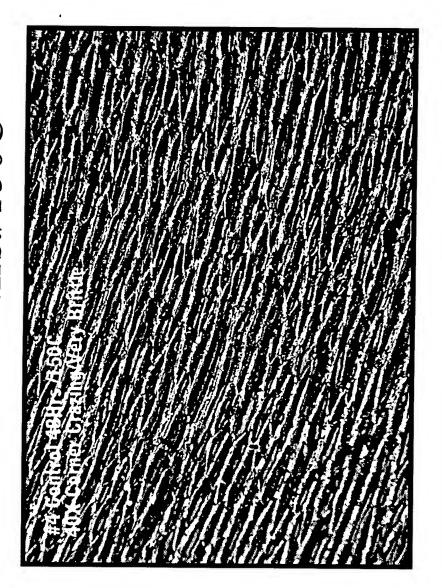
FIG. 5

Sample 4 Surface Photo 40X After 48 Hrs./150C
